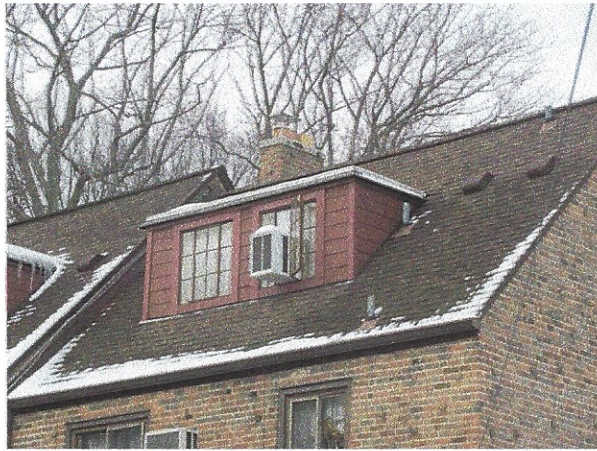
Laminate shingles

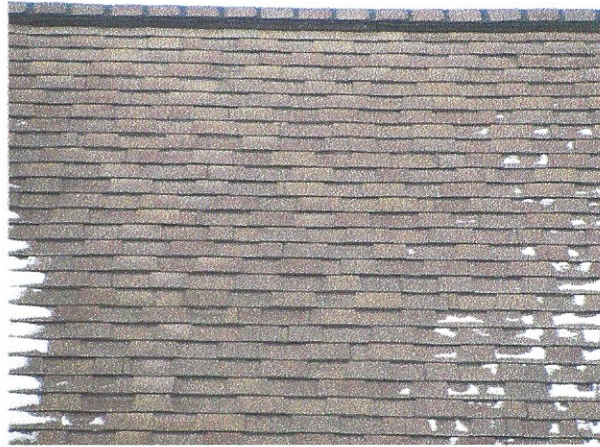
Laminate shingles

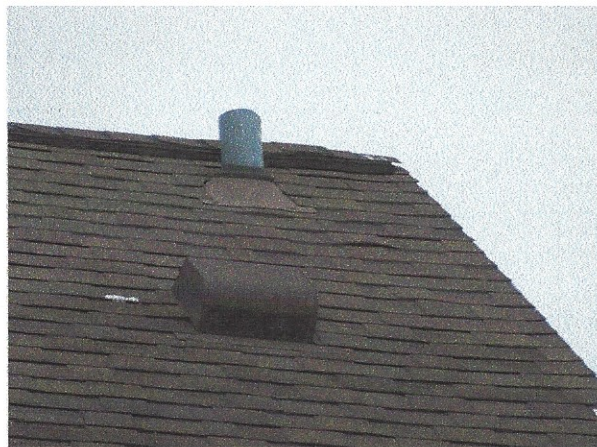
Condition: Fair overall with shingle lift and deterioration, and several locations of granular loss evident from our visual inspection from the ground. Management informs us of a history of leaks but none are active.

Minor shingle lift

Expenditure Detail Notes: Expenditure timing and costs are depicted in the **Reserve Expenditures** table in Section 3. We base our cost on replacement with standard laminate Class A 240-260-pounds per square shingles.

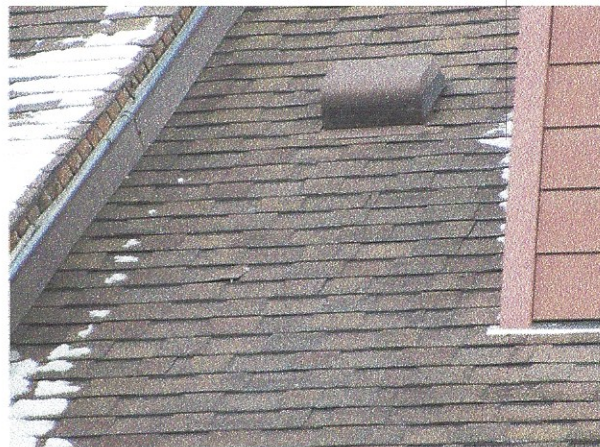
Granular loss at shingles

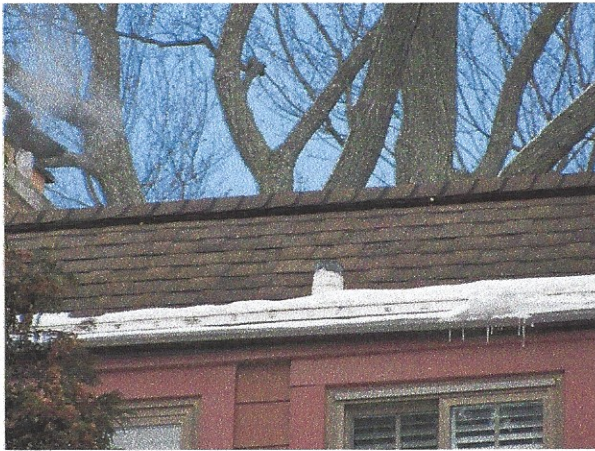
Granular loss

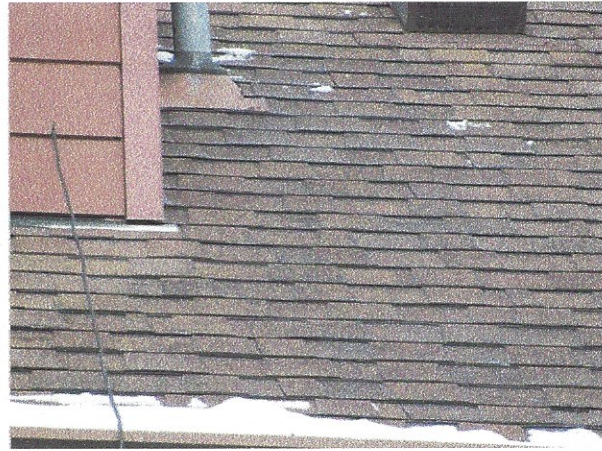
Granular loss

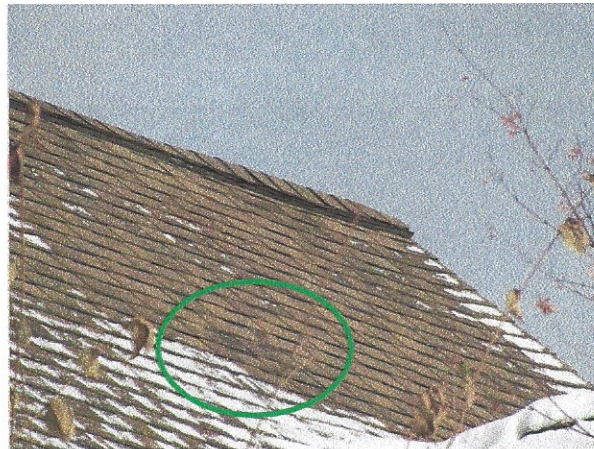
Deteriorated shingles

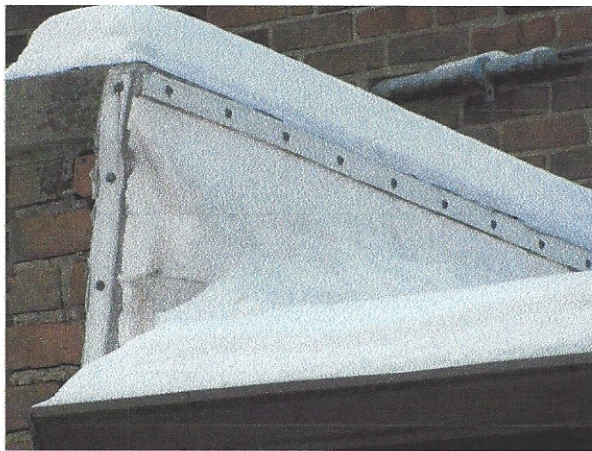
Condition: Reported fair overall. Management does not report a significant history of leaks.

Thermoplastic roof at garage

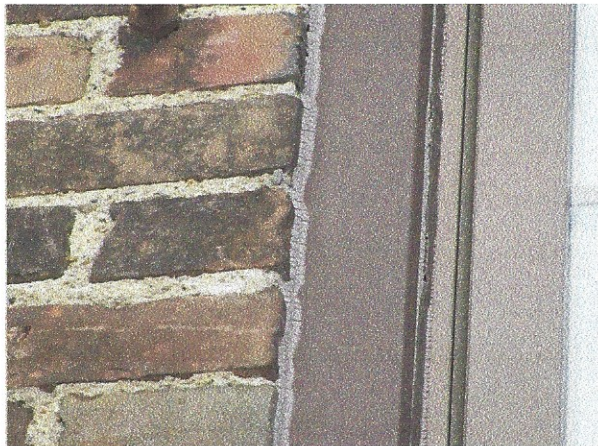
Condition: Fair overall with brittle sealants, cohesive failure and sealant cracks evident

Brittle sealant

Expenditure Detail Notes: Expenditure timing and costs are depicted in the **Reserve Expenditures** table in Section 3. We recommend St. Clair Terraces replace up to twenty-five percent (25%), or 2,100 linear feet of joint sealant by 2022 and again by 2023, and every eight years thereafter in conjunction with phased masonry repairs.

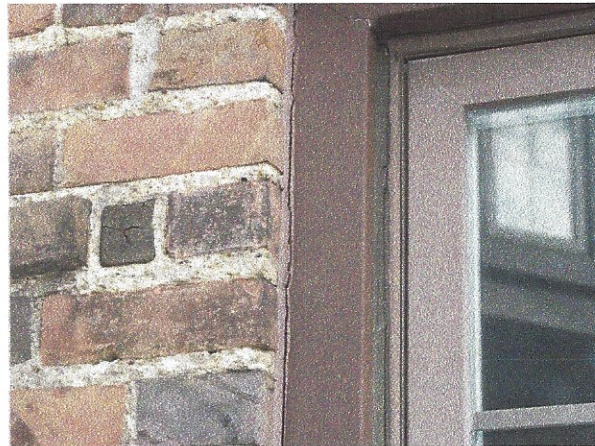
Sealant crack

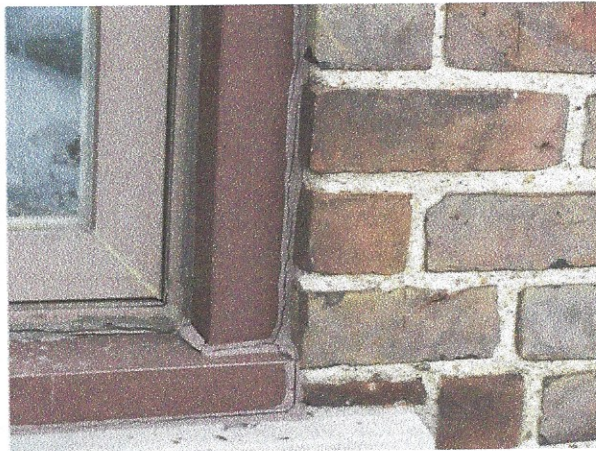
Sealant cracks

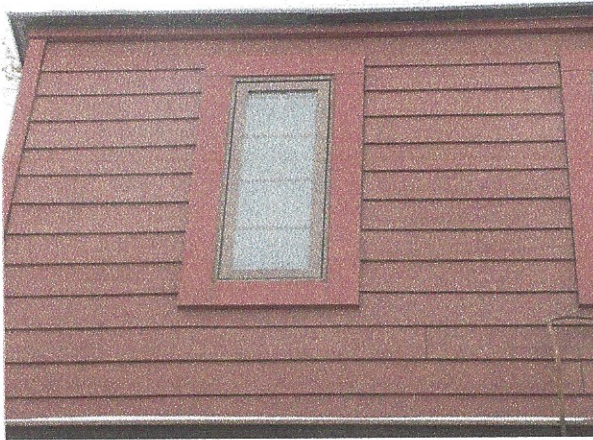
Fiber cement siding

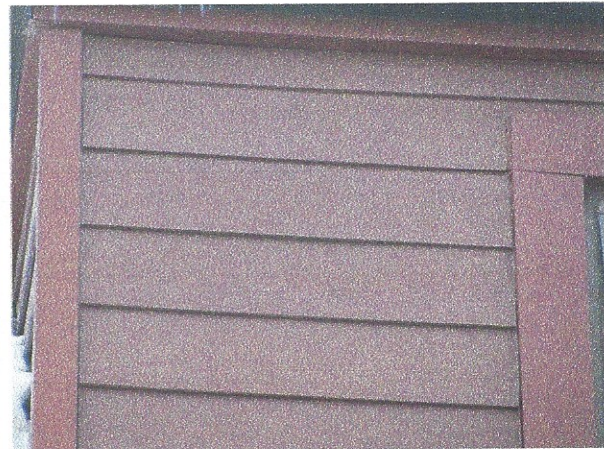
Fiber cement siding in good condition

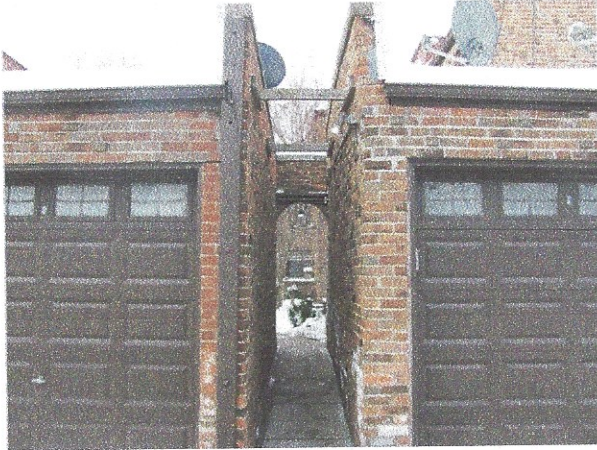
Garage walls exhibit movement

Expenditure Detail Notes: Expenditure timing and costs are depicted in the **Reserve Expenditures** table in Section 3. Management informs us the Association acquired a bid estimate to repair/rebuild the garage and storage room walls for approximately \$23,000 to \$25,000, and we include this expenditure in 2018. Our cost for subsequent repairs to all the masonry walls includes the following activities:

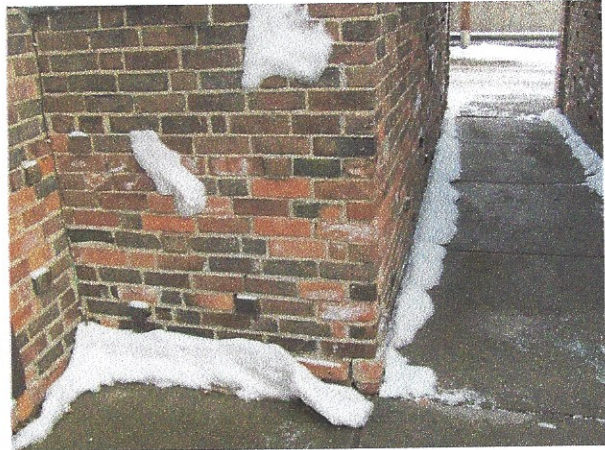
Spalled and deteriorated masonry at garage

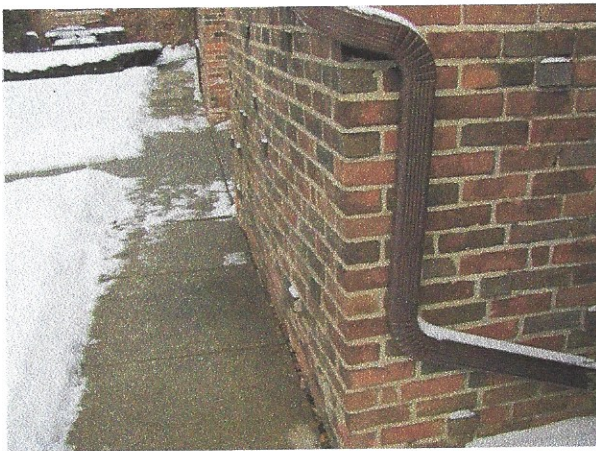
Bulge at storage room adjacent to garage

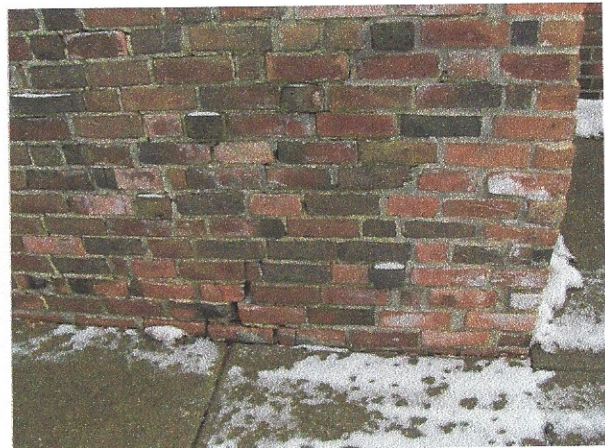
Previous repairs and recurring deterioration at storage room

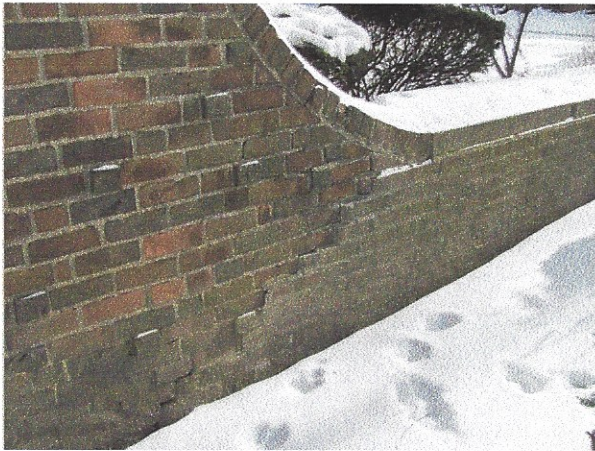
Step crack and movement evident at front perimeter wall

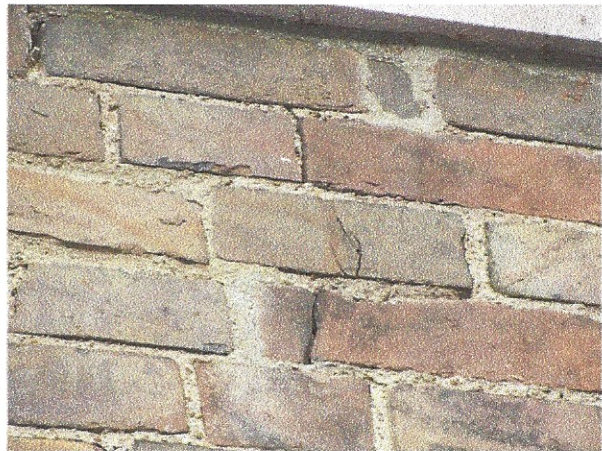
Masonry cracks

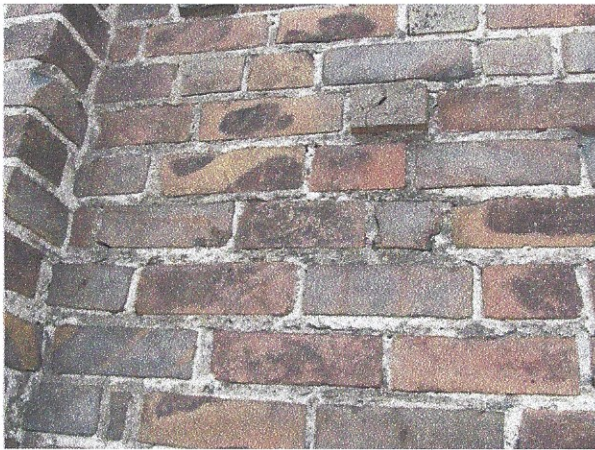
Typical mortar deterioration

- Complete inspection of the masonry
- Repointing of up to eight percent (8%) of the masonry
- Replacement of a limited amount of the masonry

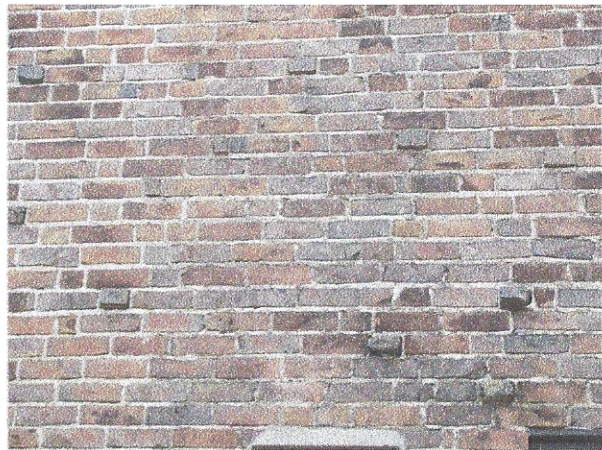
Typical mortar deterioration

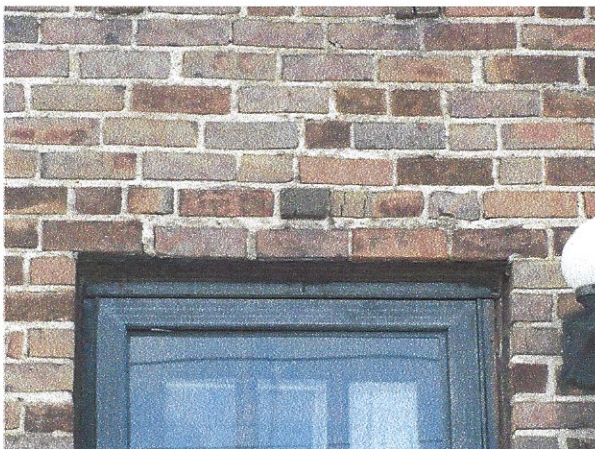
Lintel deflection

Component Detail Notes: We recommend an inspection, repair and replacement of the steel lintels. Lintels are structural supports or beams above windows and doors. Fatigued lintels also allow the direct penetration of storm water into the wall assembly. These inspections should locate areas of rust on the lintels and cracks or other structural damage to the walls around lintels. The contractor should remove any areas of rust, prime and paint these lintels. Paint protects and maximizes the remaining useful life of the lintels and therefore the exterior wall systems. Structural damage can eventually lead to costly replacements of lintels and surrounding wall systems. The following diagram details a typical metal lintel and weep system and may not reflect the actual configuration at St. Clair Terraces:

- Replacement/flashing installation at up to two percent (2%) of the metal lintels
- Paint applications to the metal lintels (approximately 1,650 linear feet)

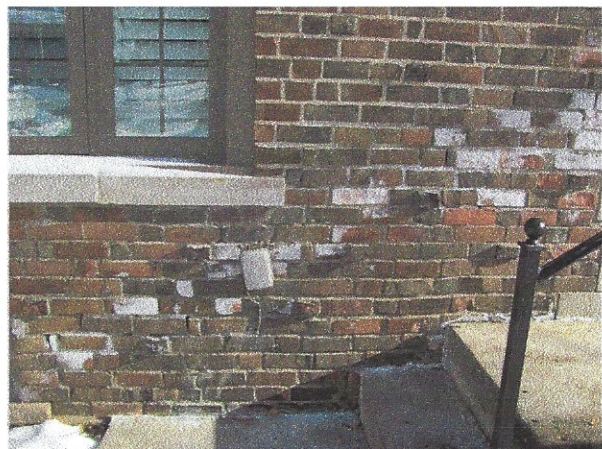
Efflorescence

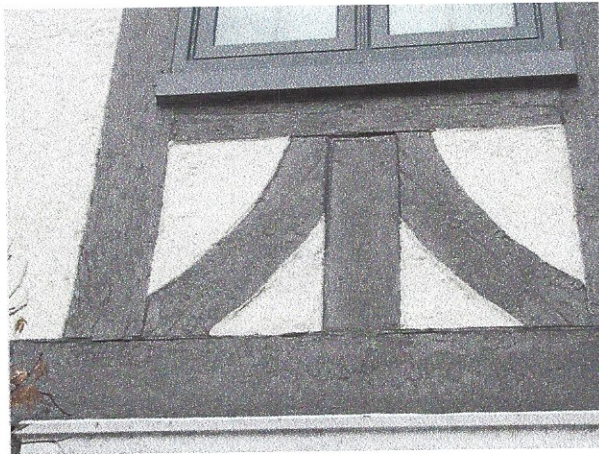
Stucco and wood finish

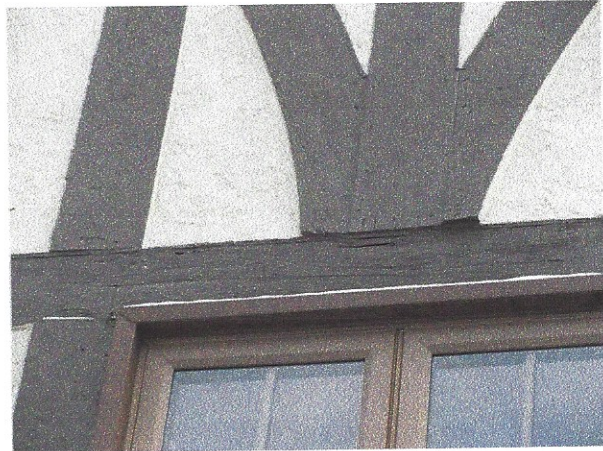
Weathered wood

- Crack repairs as needed (Each paint product has the limited ability to cover and seal cracks but we recommend repair of all cracks which exceed the ability of the paint product to bridge.)
- Replacement of up to two percent (2%), of the stucco walls (The exact amount of area in need of replacement will be discretionary based on the actual future conditions and the desired appearance.)
- Replacement of up to six percent (6%) of the wood trim

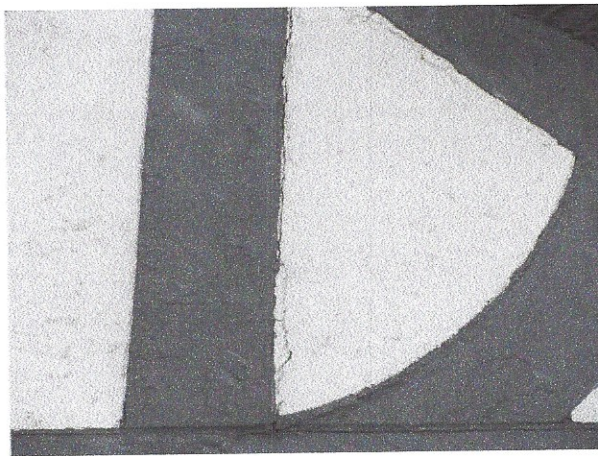
Stucco crack

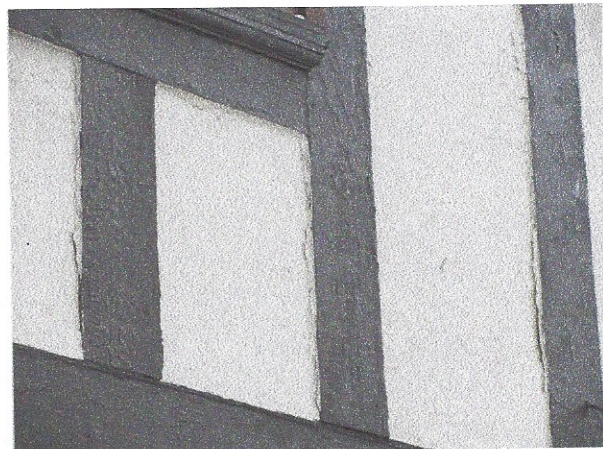
Stucco deterioration at wood interface

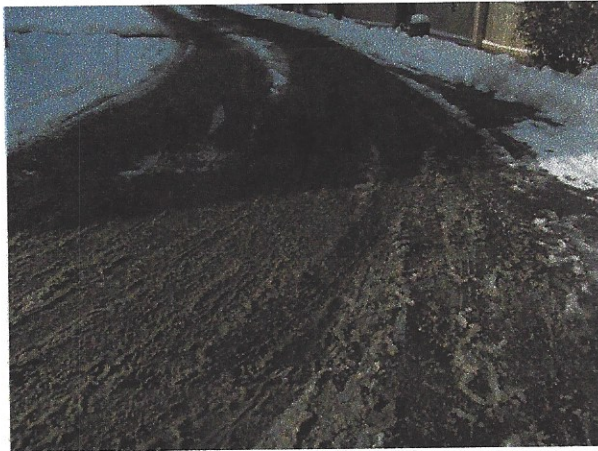
Asphalt pavement

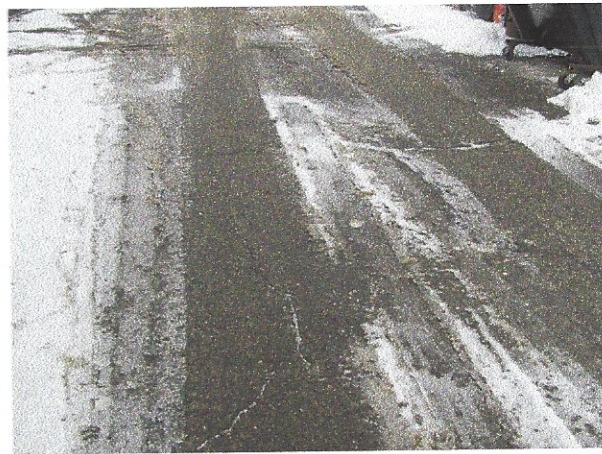
Cracks and settlement evident at asphalt pavement

The manner of repaving is either a mill and overlay or total replacement. A mill and overlay is a method of repaving where cracked, worn and failed pavement is mechanically removed or milled until sound pavement is found. A new layer of asphalt is overlaid atop the remaining base course of pavement. Total replacement includes the removal of all existing asphalt down to the base course of aggregate and native soil followed by the application of two or more new lifts of asphalt. We recommend mill and overlayment on asphalt pavement that exhibits normal deterioration and wear. We recommend total replacement of asphalt pavement that exhibits severe deterioration, inadequate drainage, pavement that has been overlaid multiple times in the past or where the configuration makes overlayment not possible. Based on the apparent visual condition and configuration of the asphalt pavement, we recommend the total replacement method of repaving at St. Clair Terraces.

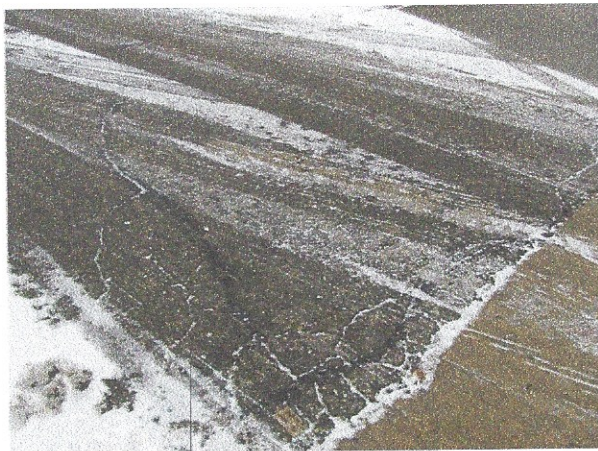
Alligator cracks

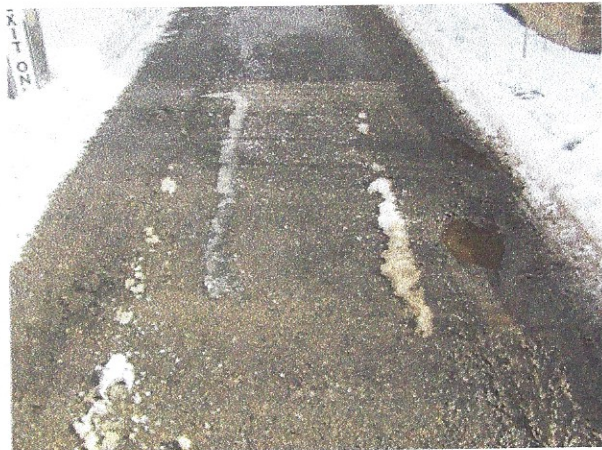
Potholes and deterioration
